January 3, 2001
NSRP 0583
N3-96-2

THE NATIONAL SHIPBUILDING RESEARCH PROGRAM

Evaluation of New Surface Preparation and Coating Repair Techniques in Ballast Tanks - Phase IV

**EVALUATION OF
NEW SURFACE PREPARATION AND COATING REPAIR
TECHNIQUES IN BALLAST TANKS-PHASE IV
TWENTY YEARS OF BALLAST TANK COATING SYSTEM TESTING**

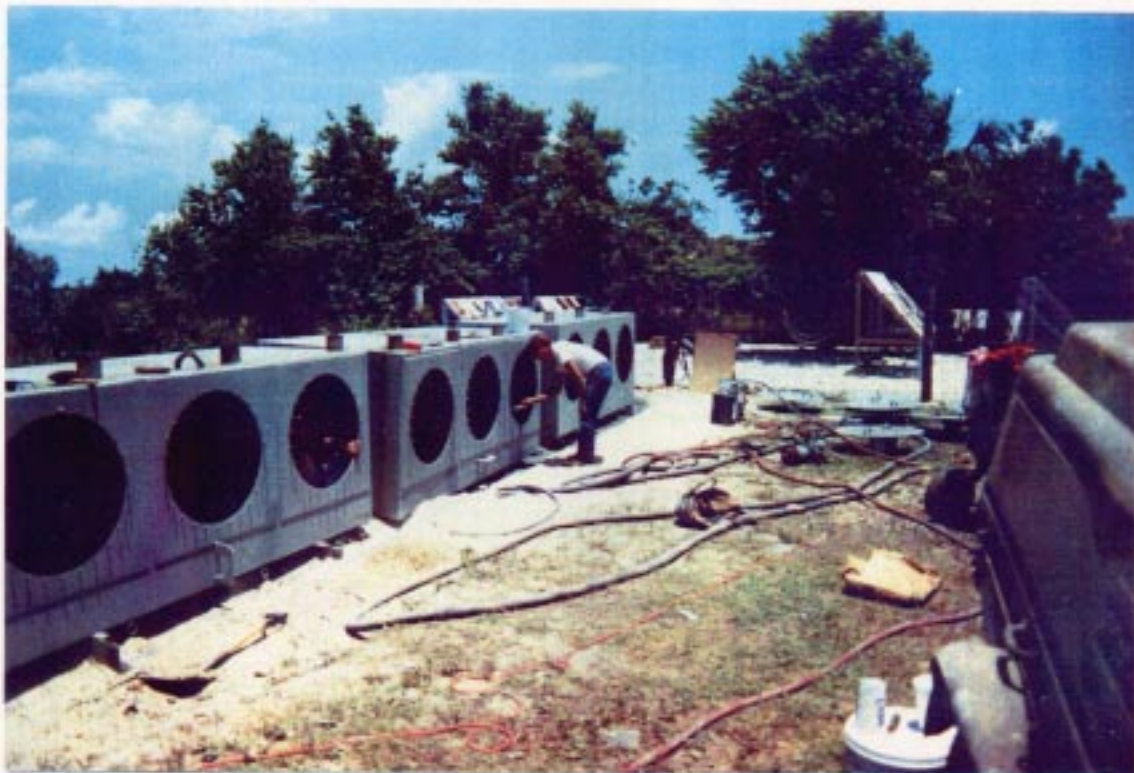
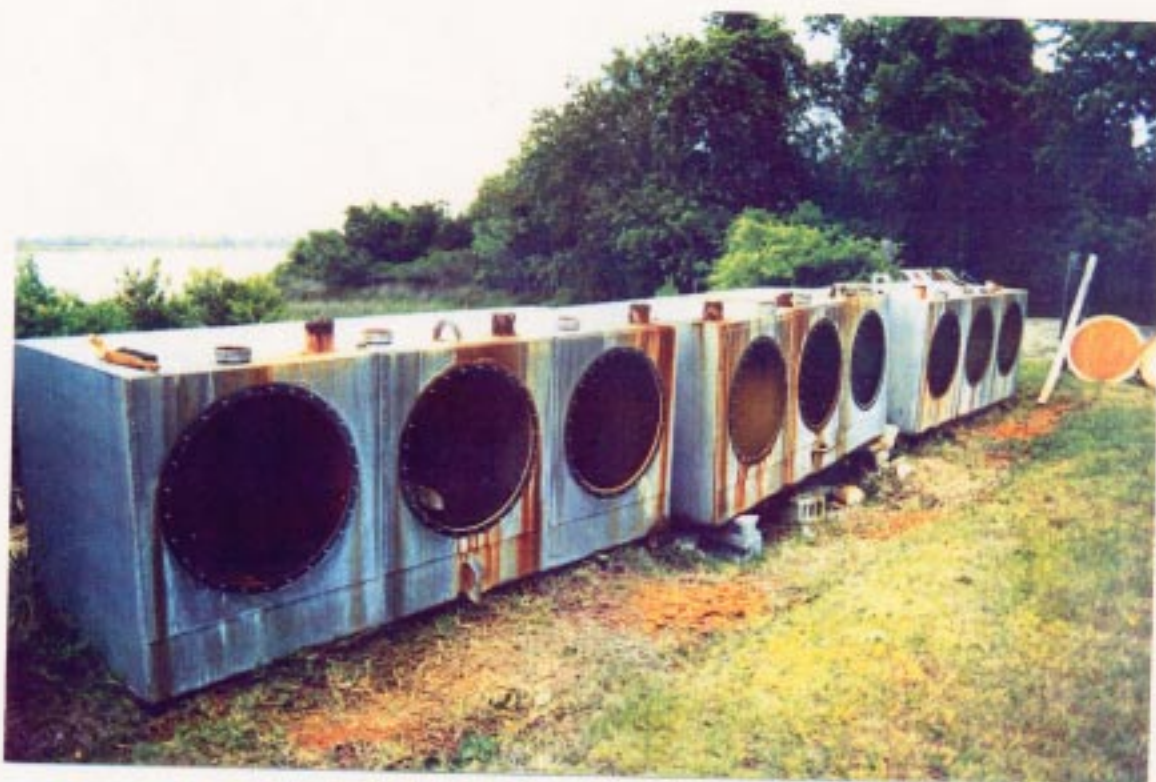
PHOTOGRAPH 1-TEST TANK ASSEMBLIES

The approximate dimensions of each tank assembly are twelve feet long by four feet wide and four feet high. Each tank assembly is divided into three separate test cells for a total of nine test tanks. Each tank assembly is constructed to simulate the internal geometry of an actual ballast tank to include angles, built up frames, "T" bars, and wide flanges. One side of each tank has bolted construction to facilitate access for coating application and inspection. See Figure 1 and Photograph 1.

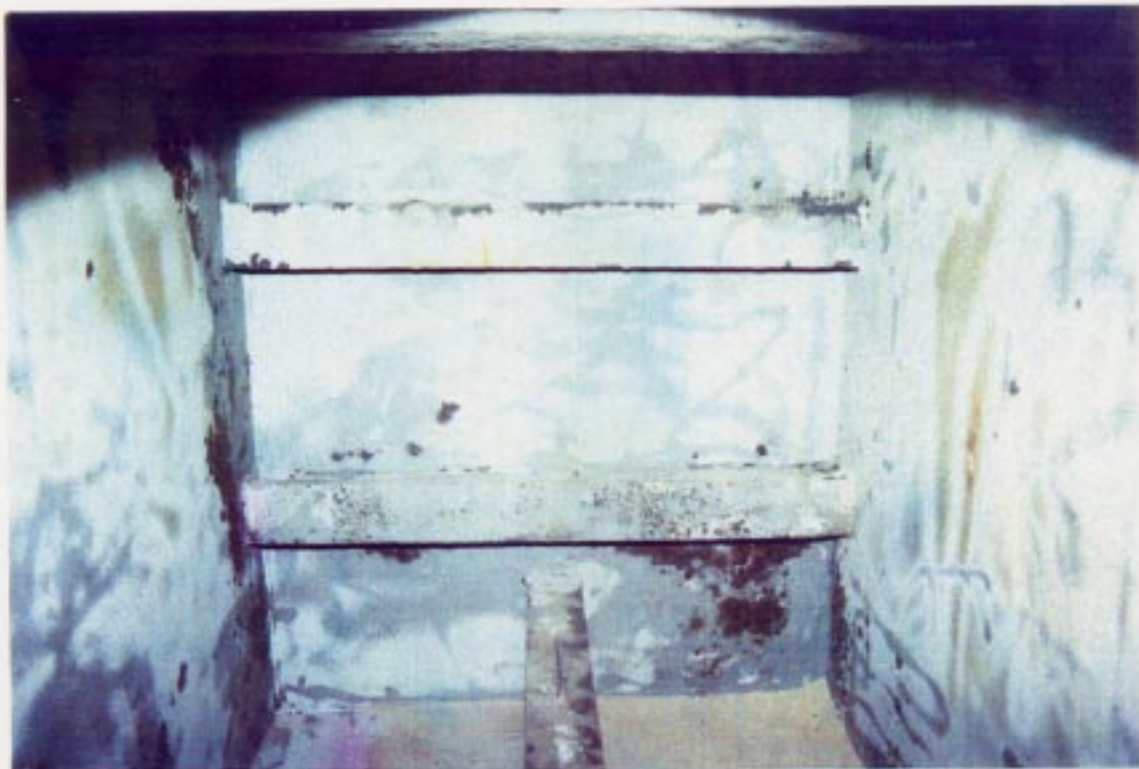
PHOTOGRAPH 2A- SWEEP BLAST CLEANED SURFACE

Hand (SSPC SP-2) and Power Tool Cleaning (SSPC SP-3) performed during the maintenance portion of the test program consisted of chipping hammers, hand and power wire brushes, and needle guns and power disc sanders. Hand sanding was used to feather the edge of intact remaining coatings. See photograph 2A (Sweep Blast Cleaned) and 2B (Hand & Power Tool Cleaned) for examples of the resultant surface preparation prior to the application Surface Tolerant Epoxy "A."

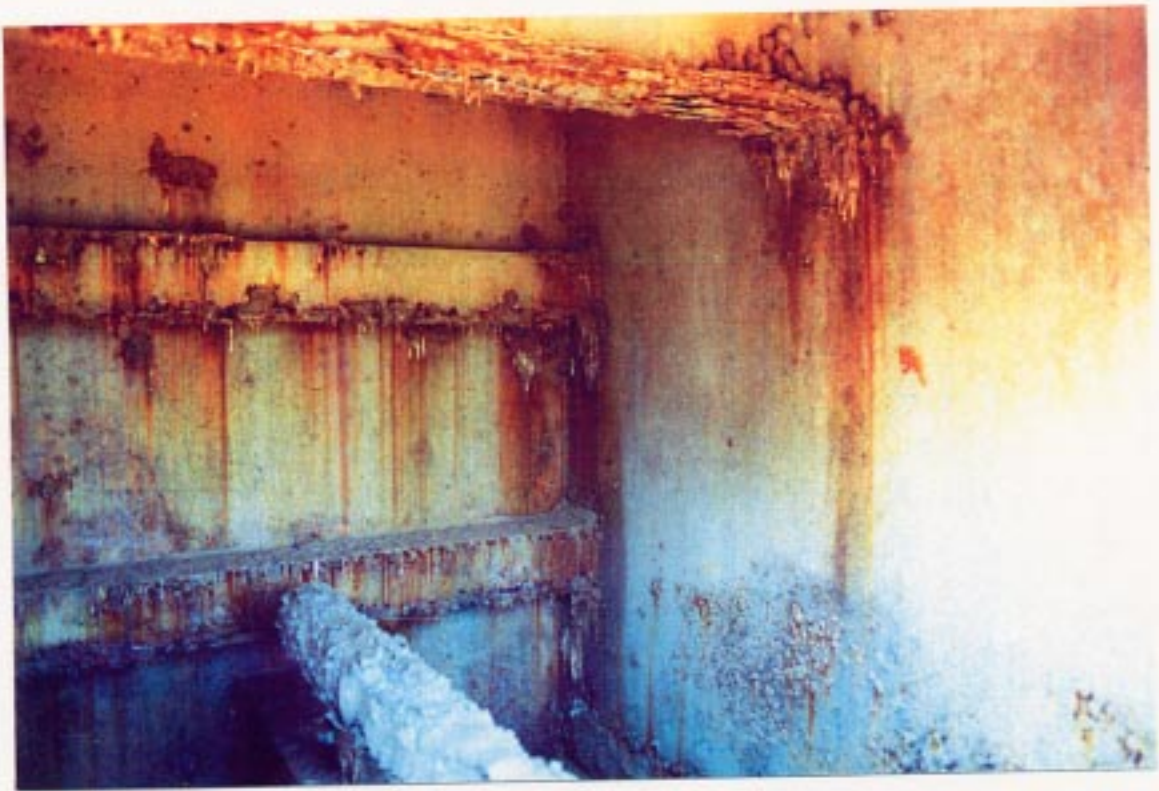
PHOTOGRAPH 10-AGED EPOXY WITH ADDED ZINC ANODE

Very little change was noted in the performance of the aged epoxy (Mil-P-23236) over the life of the system, once the zinc anode was added. This has proven to be a true twenty-year system. No new coating failure was detected in the fourteen years since the anode was added. Calcareous deposits continue to increase. Very little anode consumption was noted. See Photograph 10.

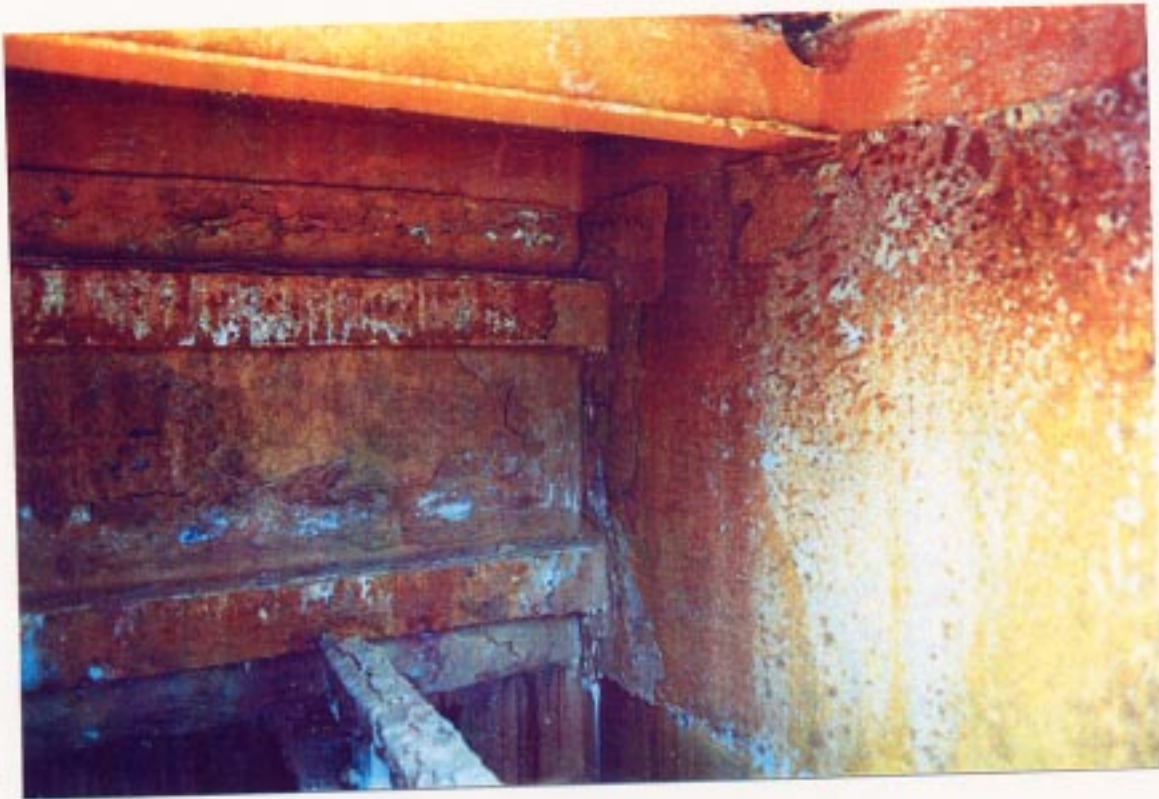
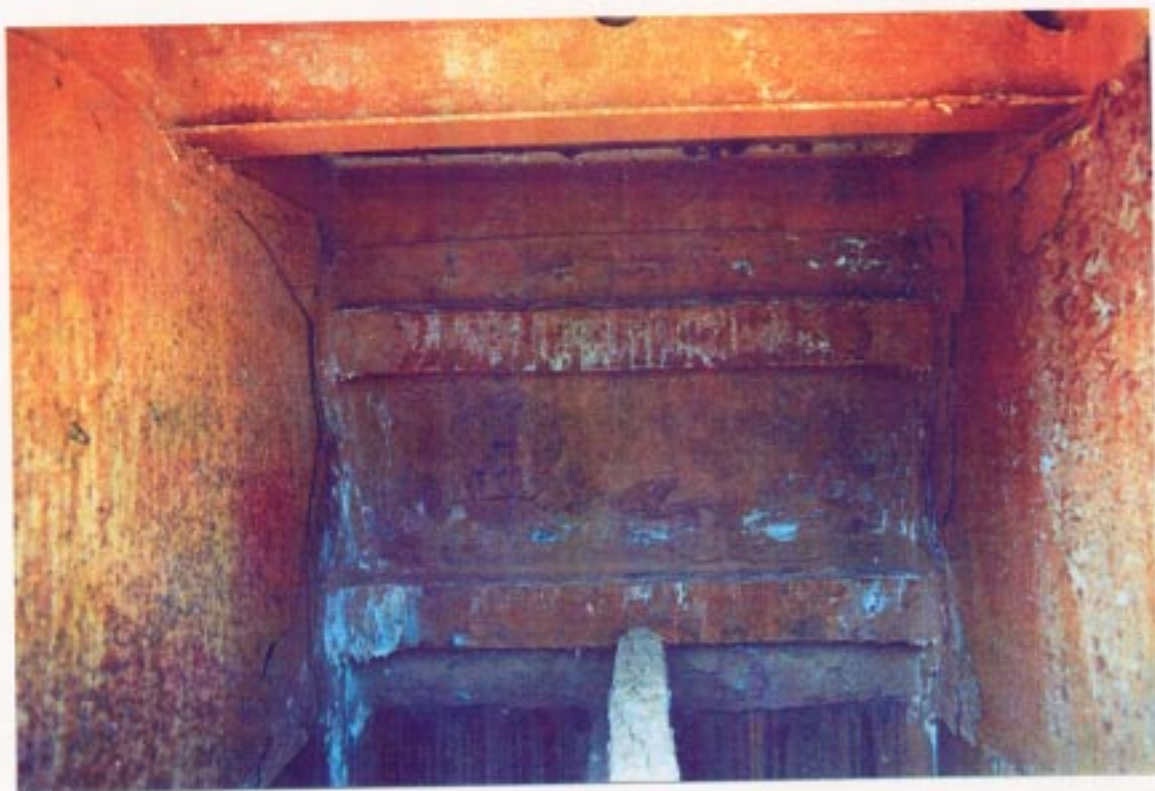
PHOTOGRAPH 11- PARTIAL COATING WITH ZINC ANODE

This system requires further evaluation prior to selection as a corrosion control alternative. It could be that the calcareous deposits initially form during the ballasted condition and provides adequate protection. As the deposit increases in thickness, there is a tendency for the deposit to dry out during the de-ballasted or dry portion of the cycle, partially detaching from the substrate, forming a void between the calcareous deposit and the steel substrate. The partially detached deposit can shield the cathodic protection from further protection of the underlying substrate. Once the deposit completely detaches and falls off the surface, new deposits form providing protection until the thickness increases. One solution may be periodic removal of all loose deposits during dry-docking and maintenance. This would be much less expensive than re-coating the tank. The loss of half the metal thickness appears severe until it is remembered that the system performed for twenty years with no maintenance except anode replacement. It should also be remembered that cathodic protection only provides protection during the wet portion of the cycle – twenty days of the thirty-day cycle. See Photograph 11.

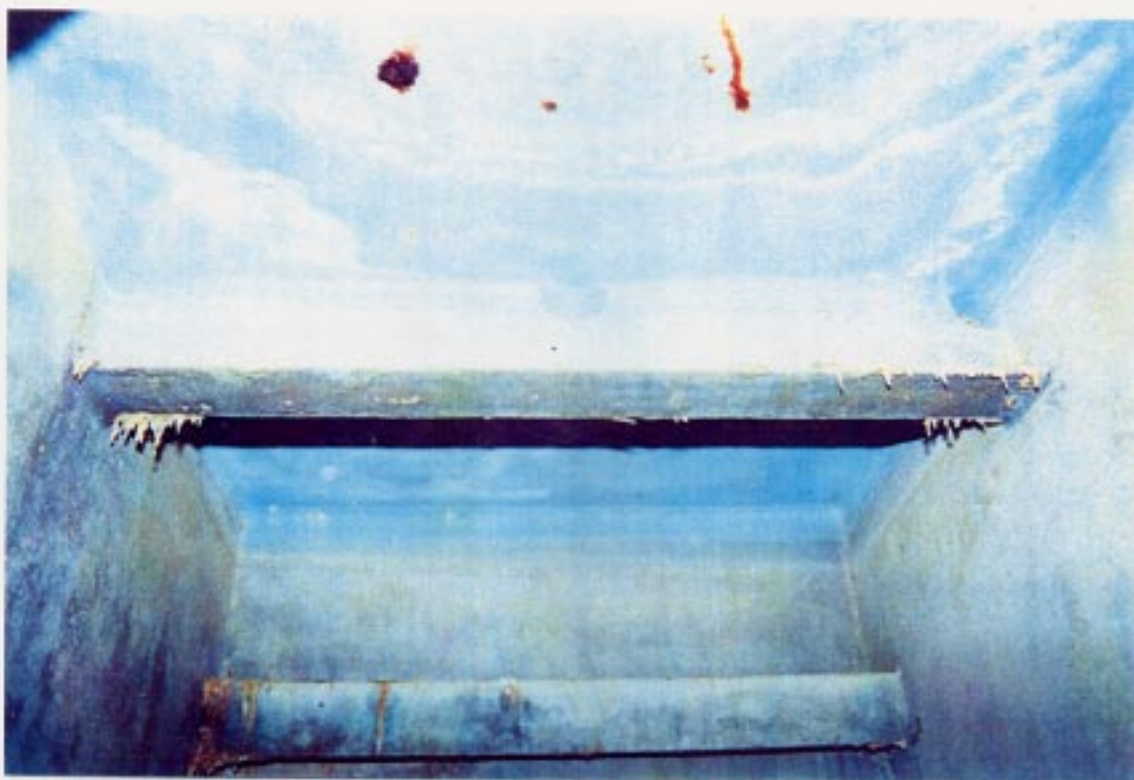
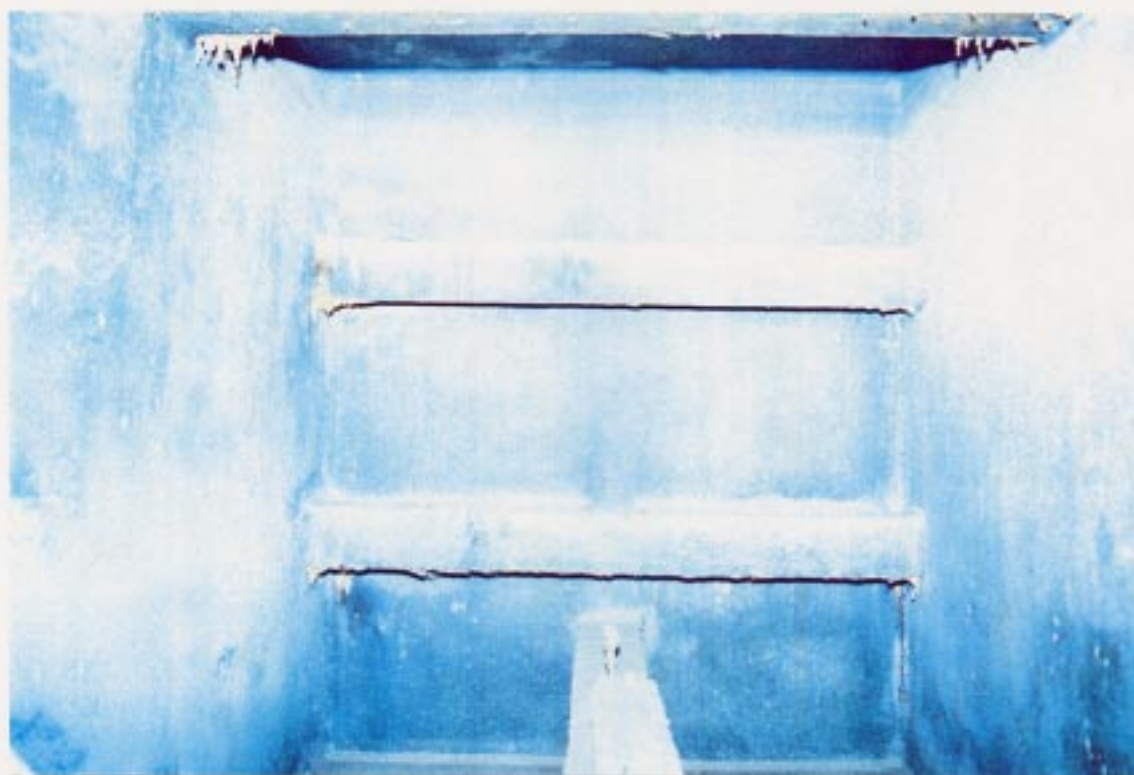
PHOTOGRAPH 12- SOLVENT BASED INORGANIC ZINC WITH ZINC ANODE

At the conclusion of seven years of testing, both the inorganic zinc with and without zinc anode are providing good protection, with the system with the zinc anode demonstrating superior performance with less than 0.03% failure. The system without the zinc anode is showing some edge failure at seven years; whereas, the system with the anode has no edge failure. Very little anode consumption was noted. Based on the earlier results, where the thin film pre-construction zinc primer went ten years prior to failure, the full thickness inorganic zinc coating with zinc anode should provide twenty years of protection, thus being a permanent system for the life of the ship. See Photographs 12, and 13.
